QUAD test setup

Fred Hartjes
NIKHEF

Nikhef/Bonn LepCol meeting
April 23, 2018

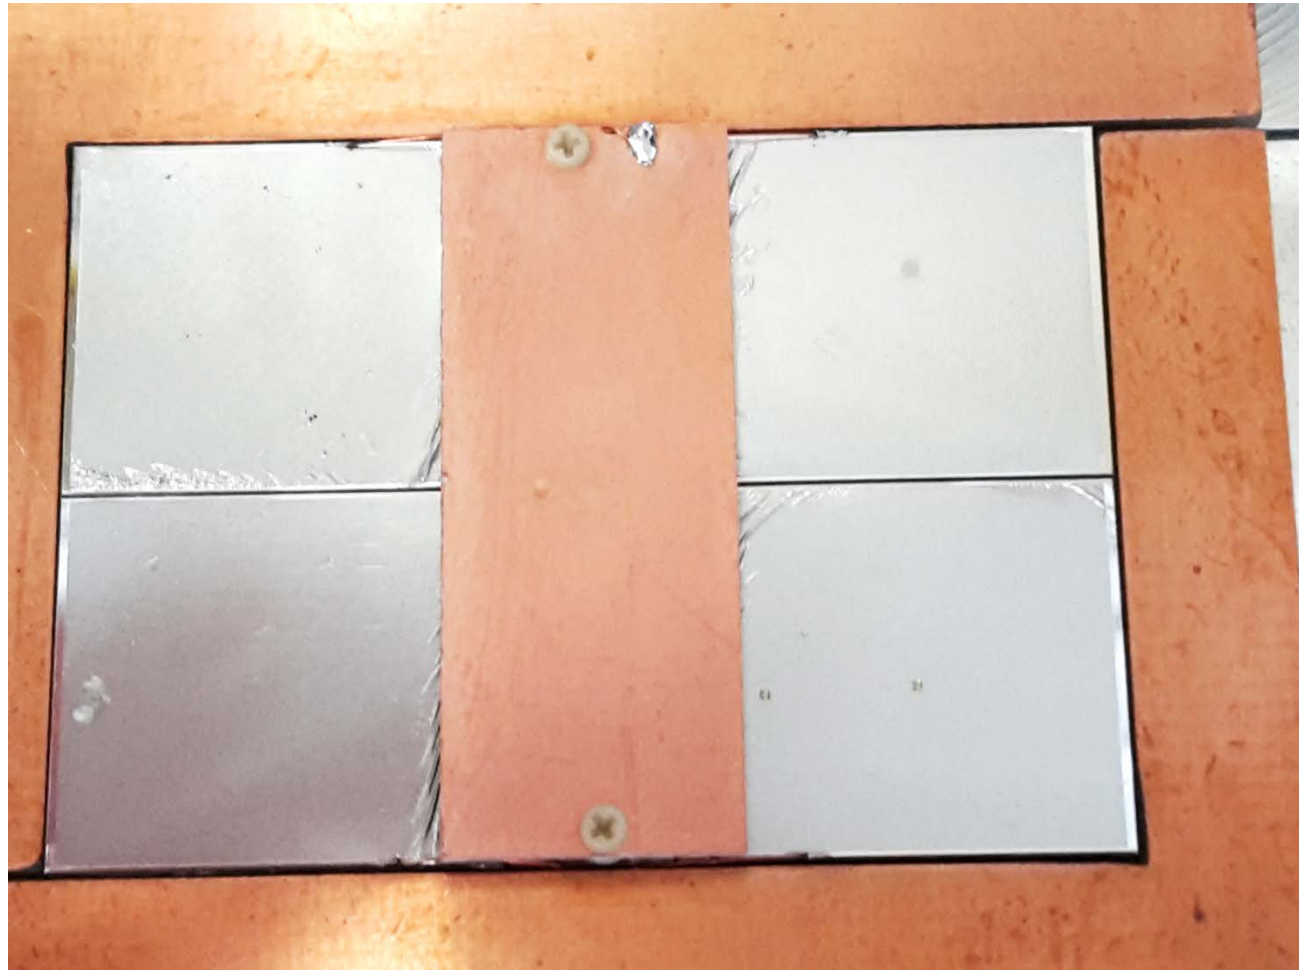
Grids of QUAD 3 not very good

- Wrinkles
- Damages
 - Repaired with Araldite
- Hard to make reliable HV connection on the 200 μm wide dyke without shorting across the 50 μm height

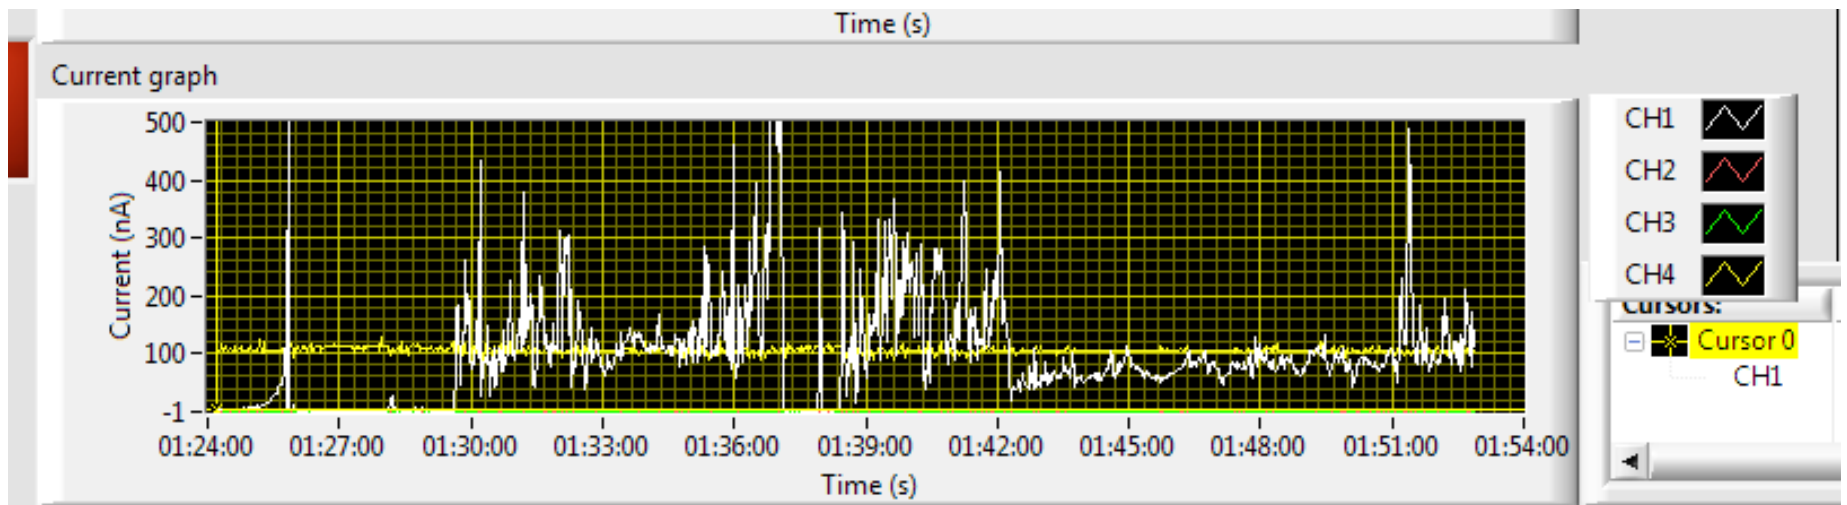
Testing QUAD3

- After some time frequent sparking problem
- Sometimes hard short

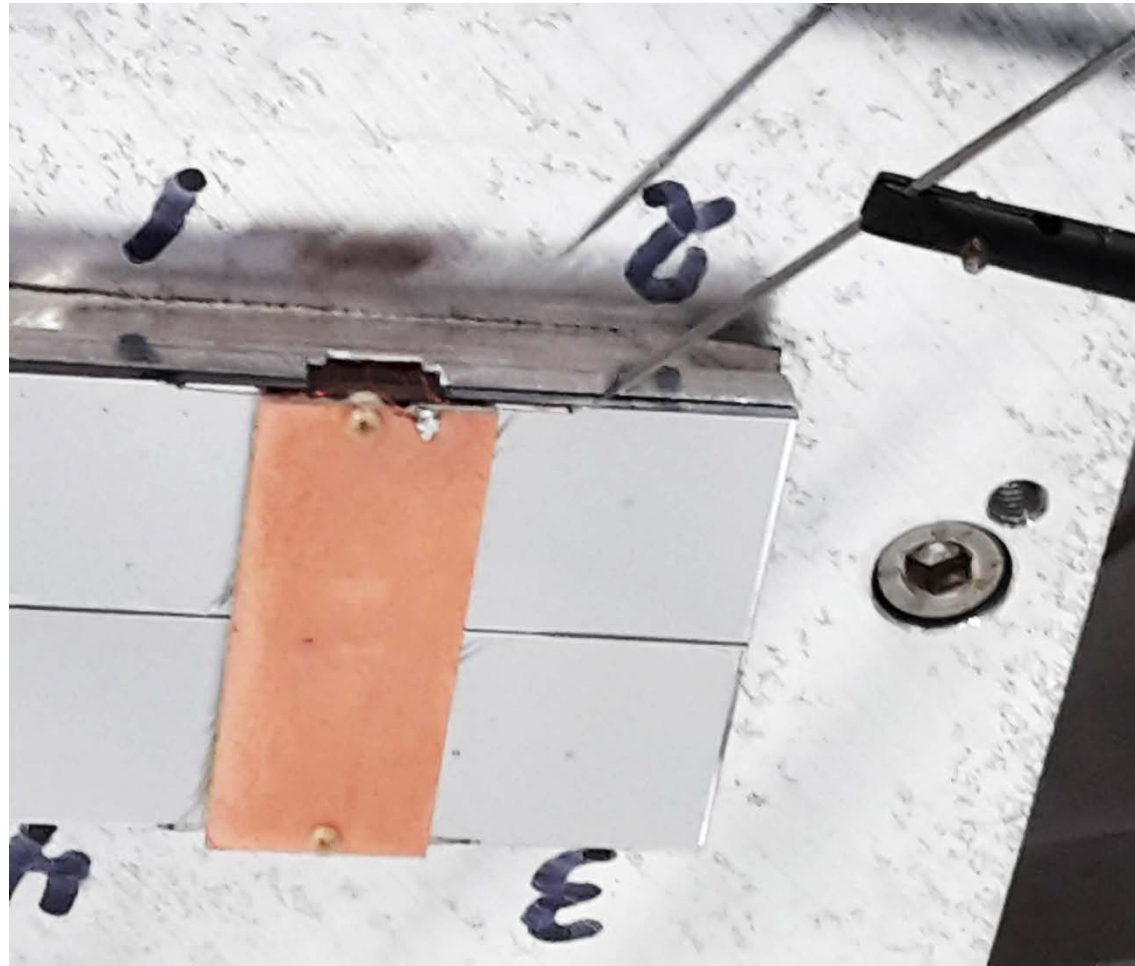
- Using sharp edge of broken probe tip
- Scraping traces of conductive glue from the dyke
- Initially successful
- But shorts started to return
- **Finally**
- No short in air
- But short/ sparking in gas

Attempts to solve the short

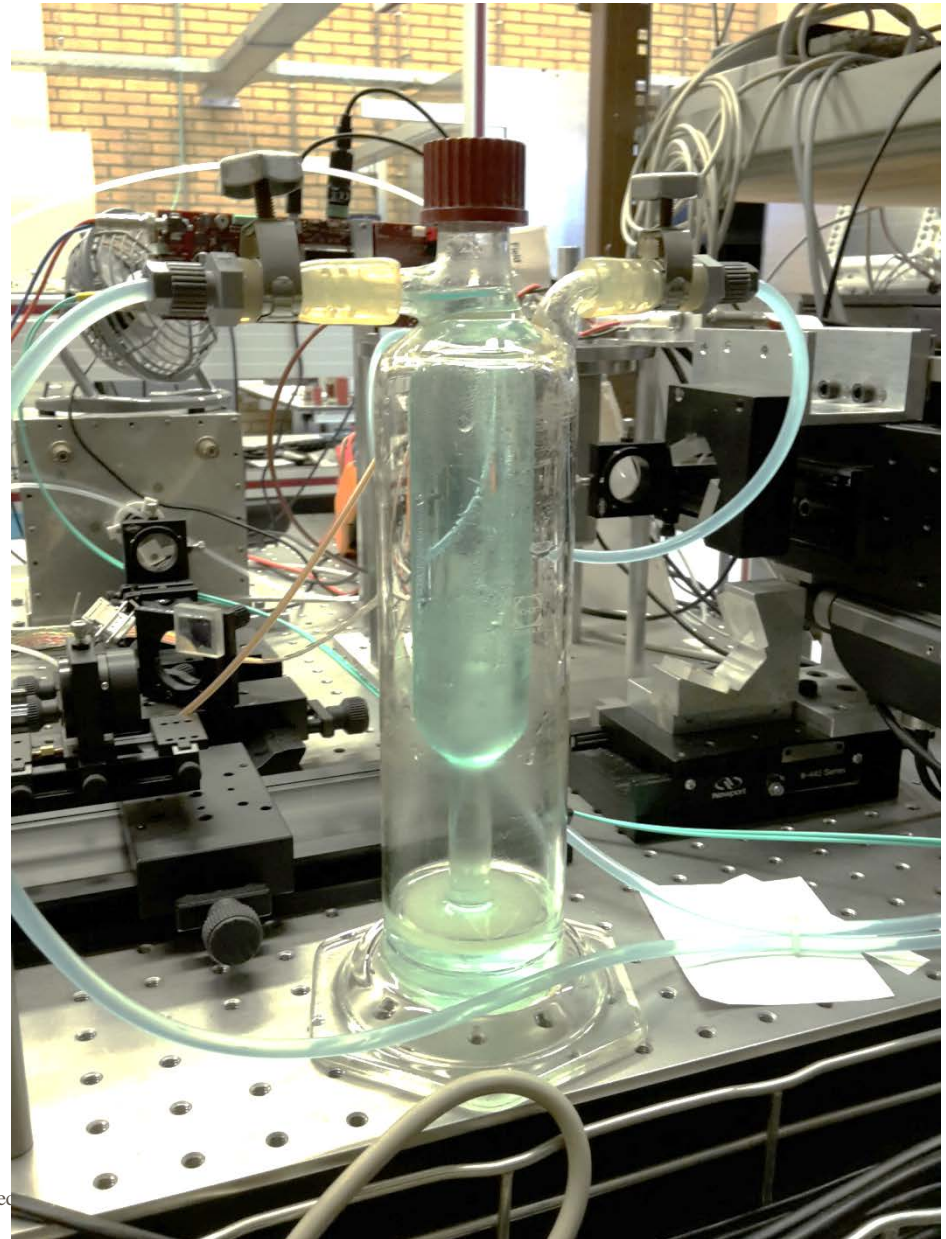
- Appears to be caused by moisture from cooling circuit.
- Chamber was already in input line of the pump
 - => underpressure
- But liquid flow goes by shocks
 - Membrane pump
 - Still overpressure when decelerating the water column
- Solved by adding a damper (gas washing bottle) between the chamber and the pump

Solution

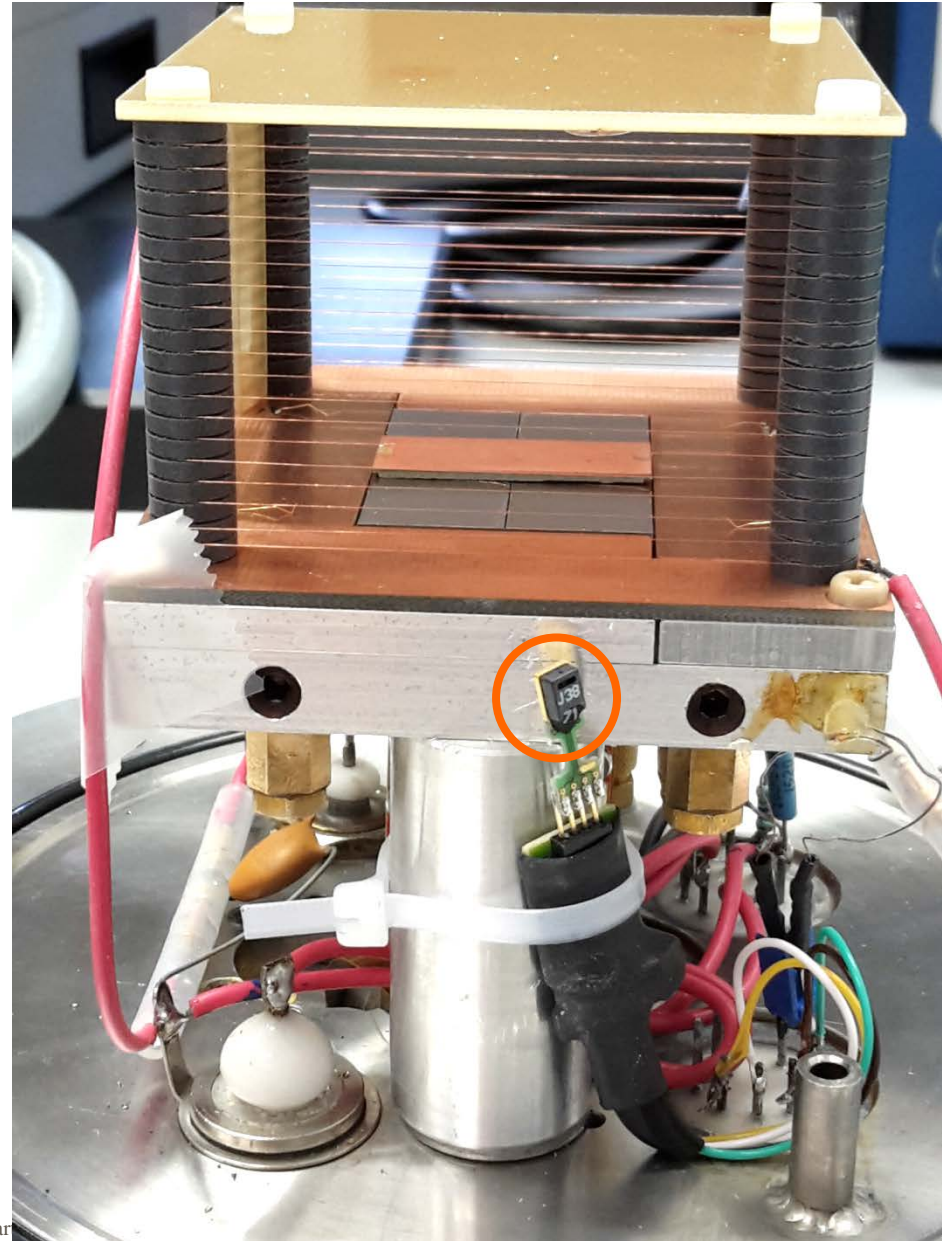
- Sensirion SHT 71
- Values logged
- Starting at 40% (dry clean room air)
- after 2 h flushing at 22%
 - Water cooling running

Moisture sensor added
