QUAD development

Fred Hartjes NIKHEF

Nikhef/Bonn LepCol meeting November 20, 2017

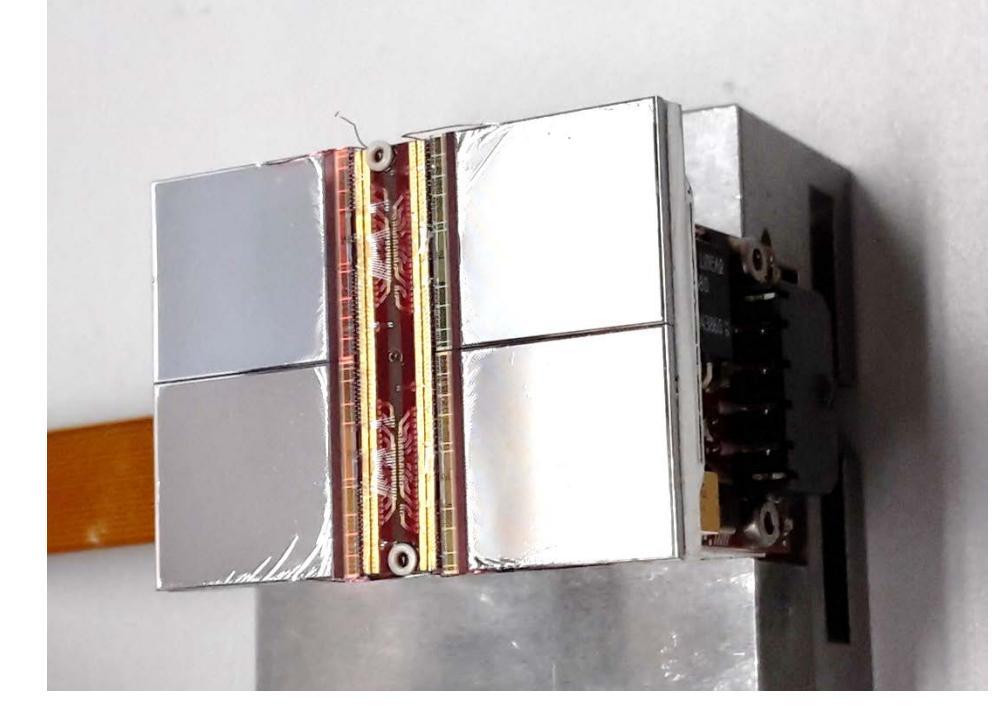
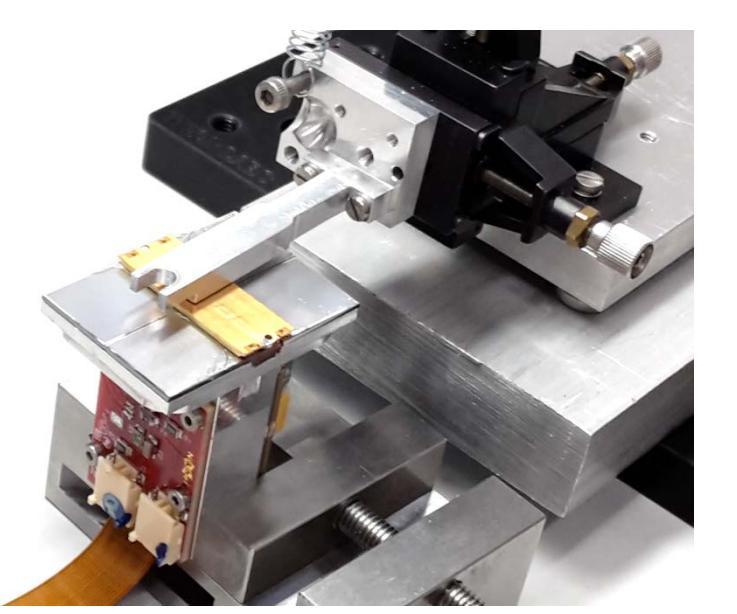
Electrical QUAD 2 assembled and installed

- 2 Class A chips, wrinkled grid
- HV grid contact to very narrow dyke very problematic
 - Delaminated at the class A chips
 - Contact by Traduct silver glue
 - Passivated by Araldite
 - Mechanical strength
 - Insulation
- Mounting guard
 - Positioning with XYZ stage
 - 2^{nd} screw (M1.2) did not fit
 - Error in hole to hole distance?
 - At both ends secured with minor amount of Araldite
 - Problem expected to be solved for new generation wirebond boards and guards
- Jean Paul is making a new guard from coppered glass fibre epoxy

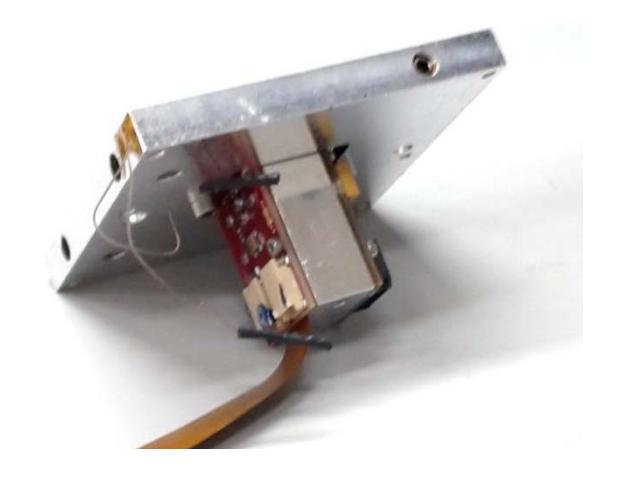
- Done with ISEG HV supply and HV probe (1 GΩ impedance)
- Grids connected by HV board
 - 100 M Ω and 50 M Ω
- Test in air
- All grids had correct HV
- Initially high current (600 nA @ 50V
 - Decreasing to 170 nA @ 200 V

- Under gas trip at 200 V
 - After 10 h at 100 V also trip
- After weekend ramping up to 200 V
 - 1st trip after 1 min
 - ^{2nd} trip after 10 min
 - **3**rd trip after 40 min

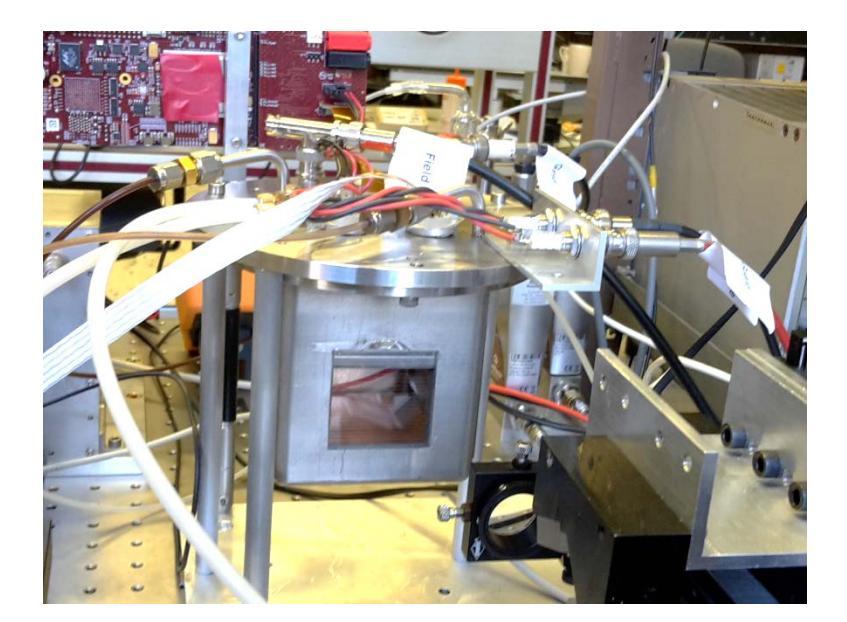
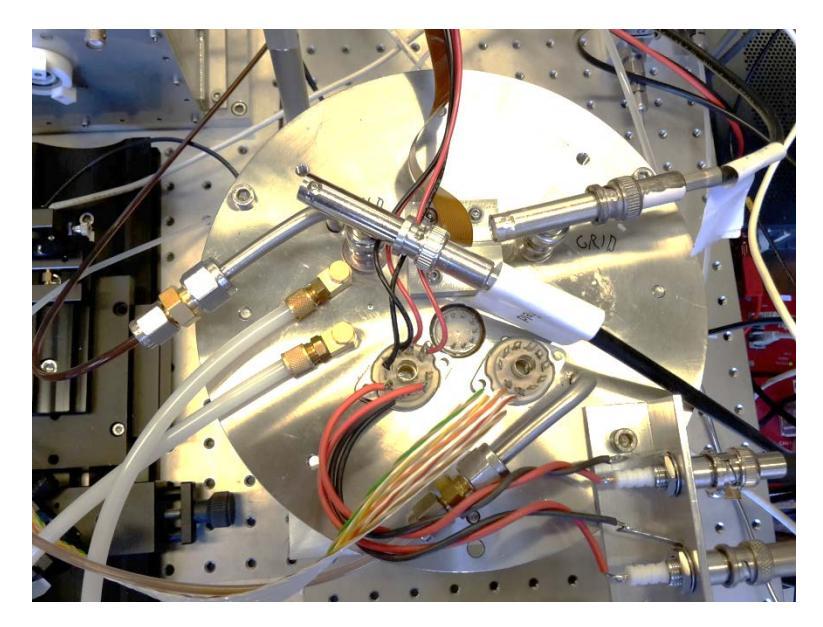
QUAD 2 tested in gas

- Flushing with T2K
 - => 2.3% O₂ at 3 ml/min on long term (box has 700 ml content)
 - => 1.1% O₂ by replacing the rubber of the flex feedthrough
- Initially HV problems
 - **Test up to 200 \text{ V} => \text{trip}**
 - Long term curing at 100 V => trip after 8 h
 - Next day ramp up to 200 V
 - Trip after 1 min
 - Trip after 10 min
 - Trip after 40 min
 - No trip until the next day
 - Can be ramped up now to 300 V
- Also too high grid current
 - Starting at 600 nA @ 50 V
 - Decreasing to about 100 nA at 200 V
- But falling down very rapidly after increasing the gas flow (2 => 16.7 ml/min)
 - => probably moisture effect on the Araldite

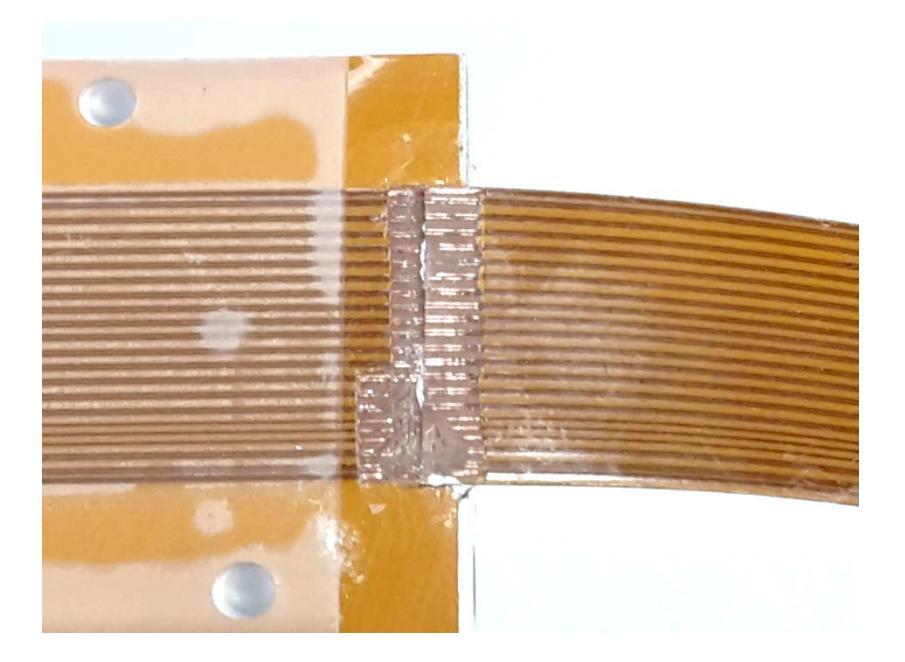
- Flex broke while replacing the cooling tubing
- Attempt to repair (conductive glue + wire bonding)
- Good result far from guaranteed
- Reinstalled in test box
 - Guard cage sparking at 300 V??
 - Waiting for DAQ test
