QUAD status New testbox

Fred Hartjes NIKHEF

Nikhef/Bonn LepCol meeting September 3, 2018

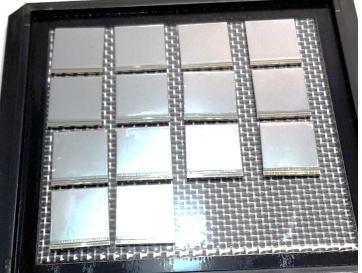
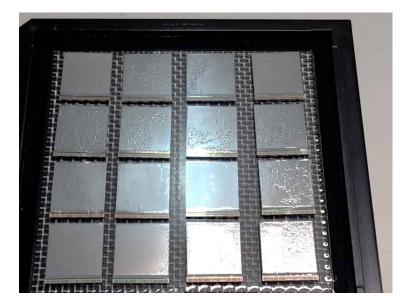
Some grids look bit messy

Occasional delamination of part the broad dyke at the wirebond side

Under the microscope

- Grids look under the microscope even better than on photographs
 - Irregularities seen on the photographs originate from minor delaminations from the pillars
 - Height deviations $5 7 \,\mu m$
 - > only limited effect on gas gain
- Conclusion: as far as can be seen from the first superficial inspection all class A and B chips can be used

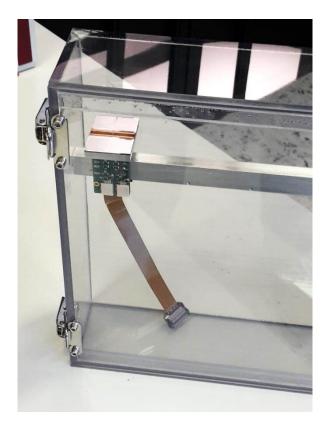
- Delay because of movement to another cleanroom (H070)
 - Vacuum, compressed air, internet to the assembly PC
- QUAD 10 (damaged flex) will be used to make demo using class K,R, .. Chips
- **QUAD** 11
 - Mostly done
 - Leak tight (< 1 ml/min)
 - Low O2 diffusion (< 30 nl/min)
 - Ref: at the present laser chamber we have 27 μ l/min
- **QUAD 12**
 - Being assembled
- **QUAD 13**
 - Assembly started

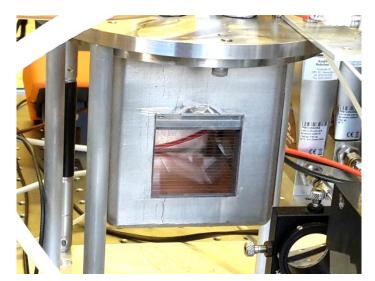
- Adjusting the detector in the beam
 - 17.8 cm above table plane
- Which degrees of freedom do we want?
 - **X**, Z

- Remote, no accuracy
- Horizontal rotation
 - (Too) small rotary table
 - Remote, bit wobbly
- Vertical rotation
 - Goniometer
