Noise modeling and attenuation relations in the EMR site

Shahar Shani-Kadmiel · 3rd ET SPB WS, Nikhef, Amsterdam · December 6-7, 2023

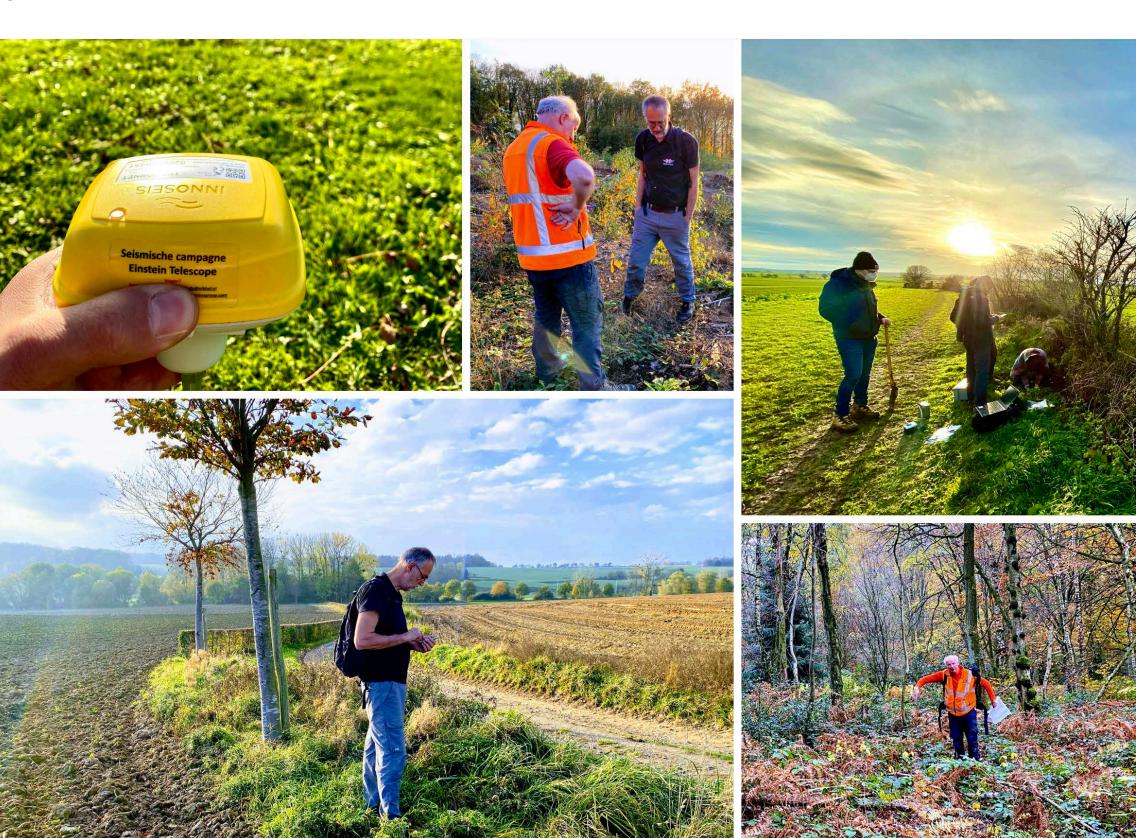
A rich network of seismic sensors

- 1. Seismic noise characterisation for the optimal location of the ET corner-points.
- 2. Imaging the subsurface to support geotechnical engineering efforts.
- 3. Extending the existing seismic network in the region: 15 new broadband seismic stations (surface) & 4 new broadband borehole seismic stations (250 m depth)

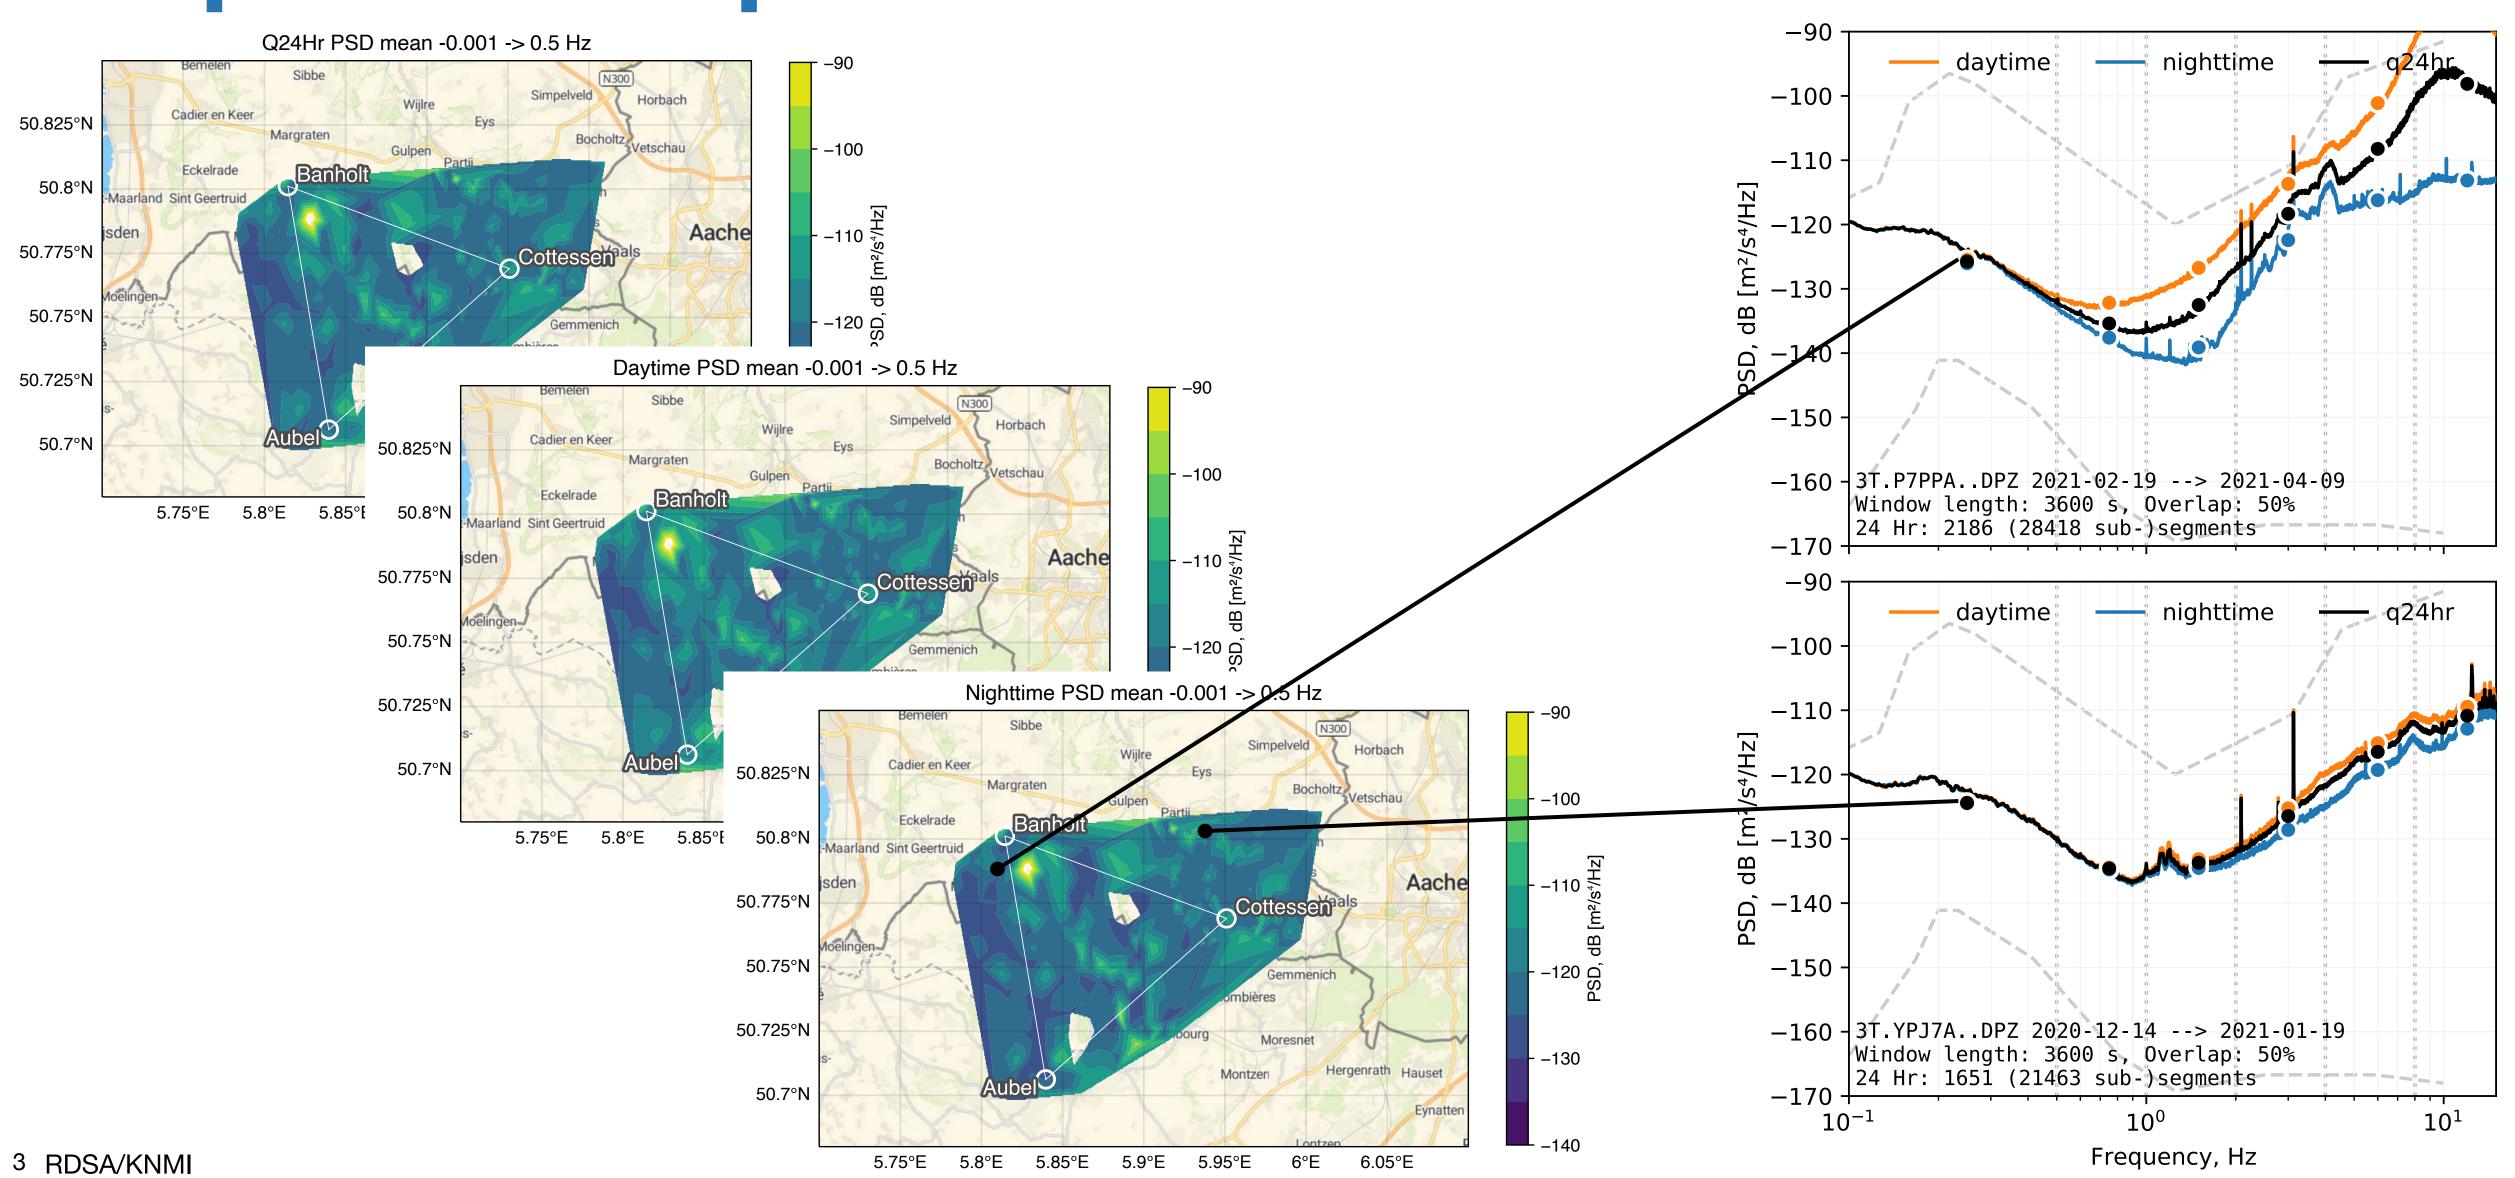
Spectral maps of seismic noise levels

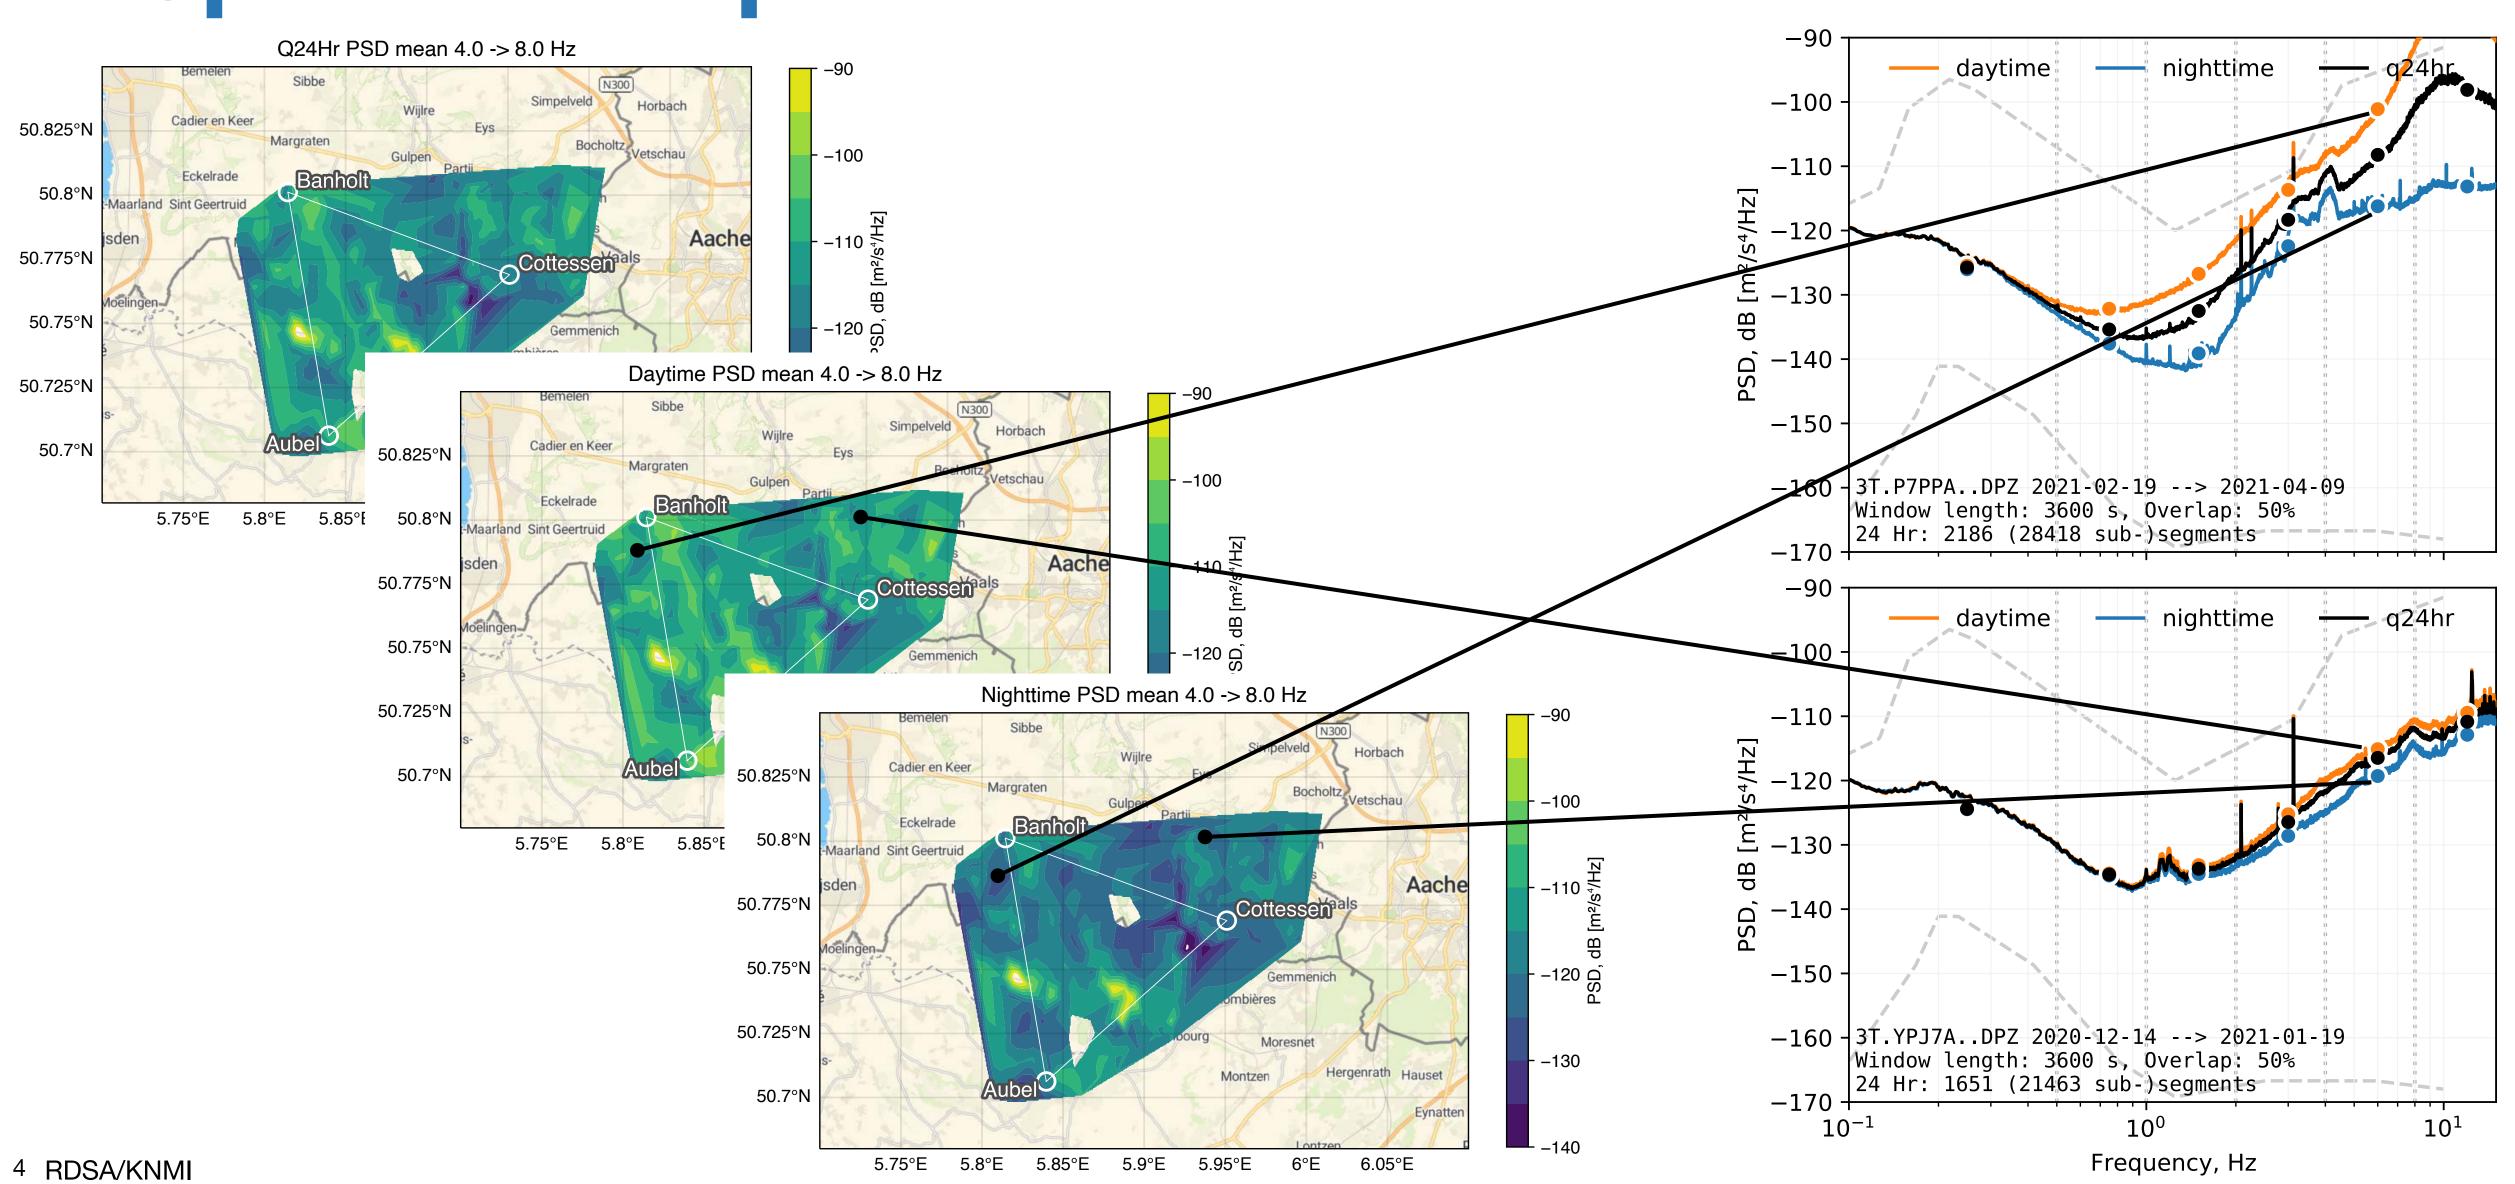
Spectral maps of seismic noise levels

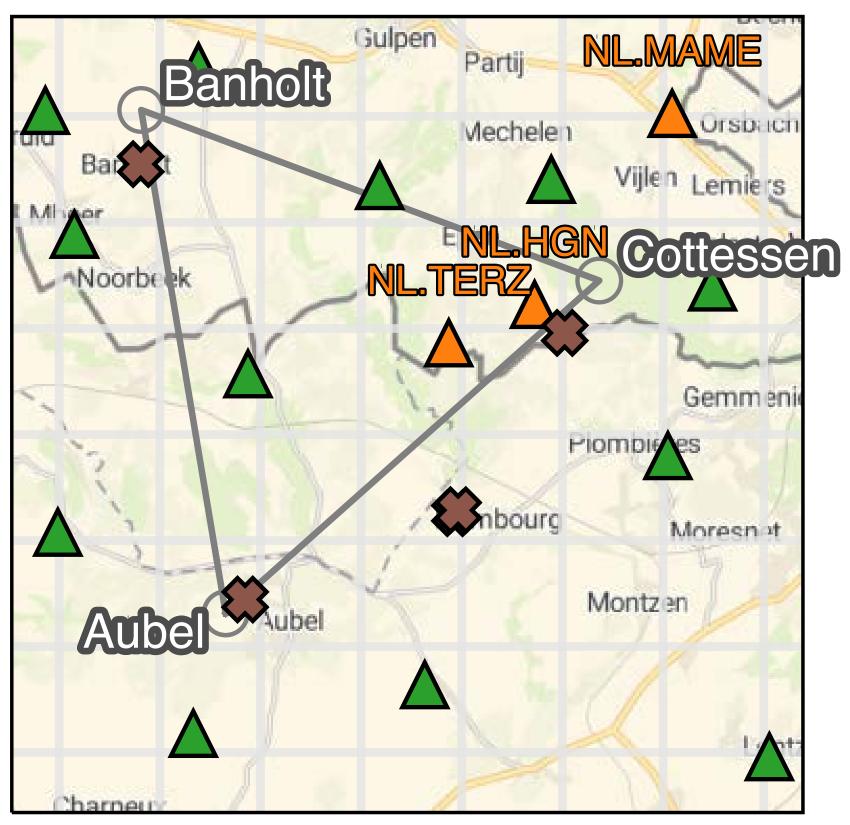
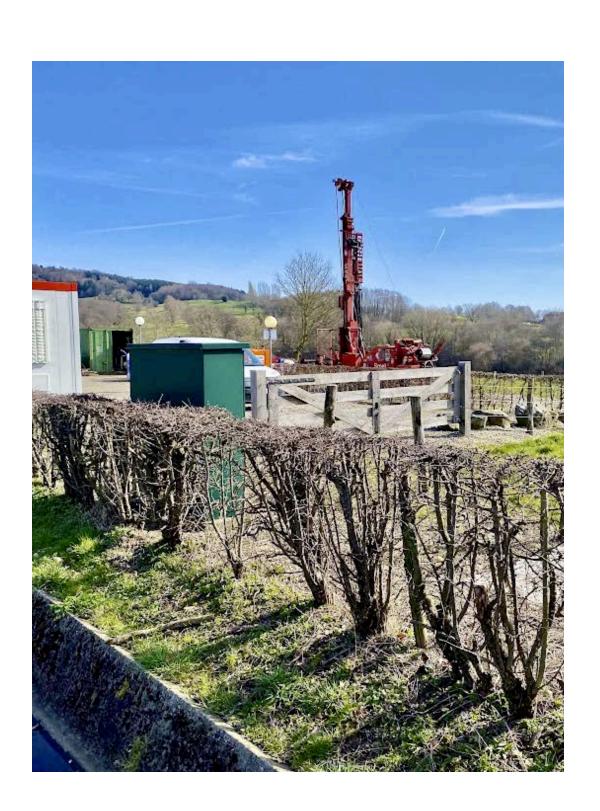
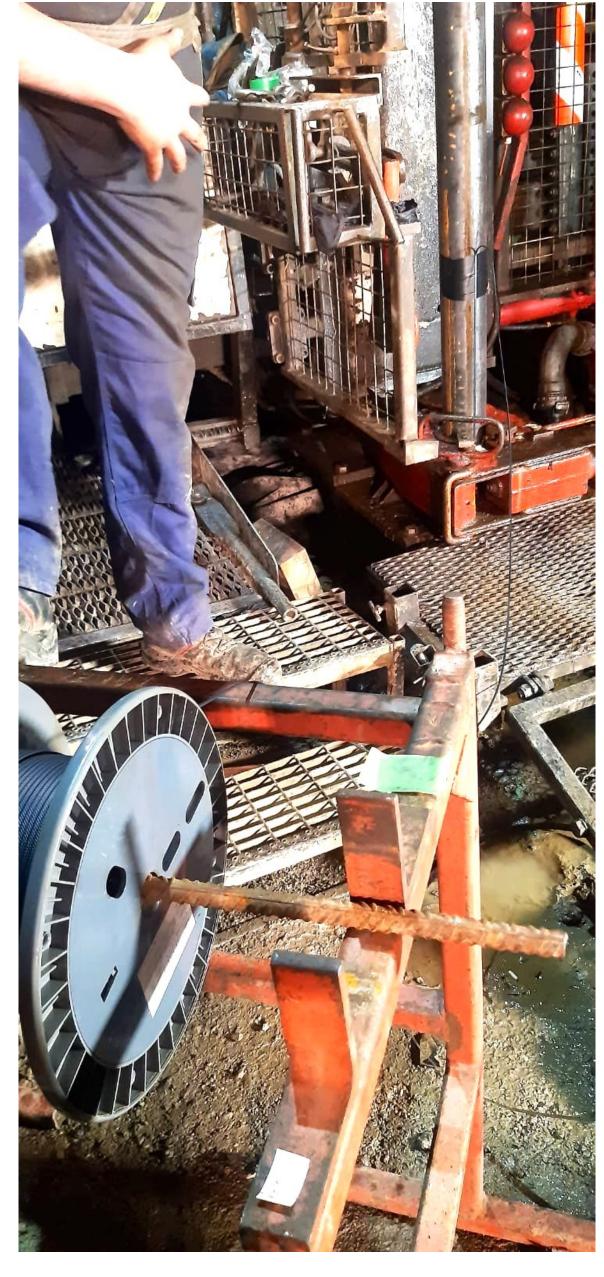
- Drilling reached 250 m depth.
- Casing and cementing of the Cottessen borehole did not go as planned...
 - Glass fibre snapped after ~30 m
 - Casing leaked cement at ~170 m depth

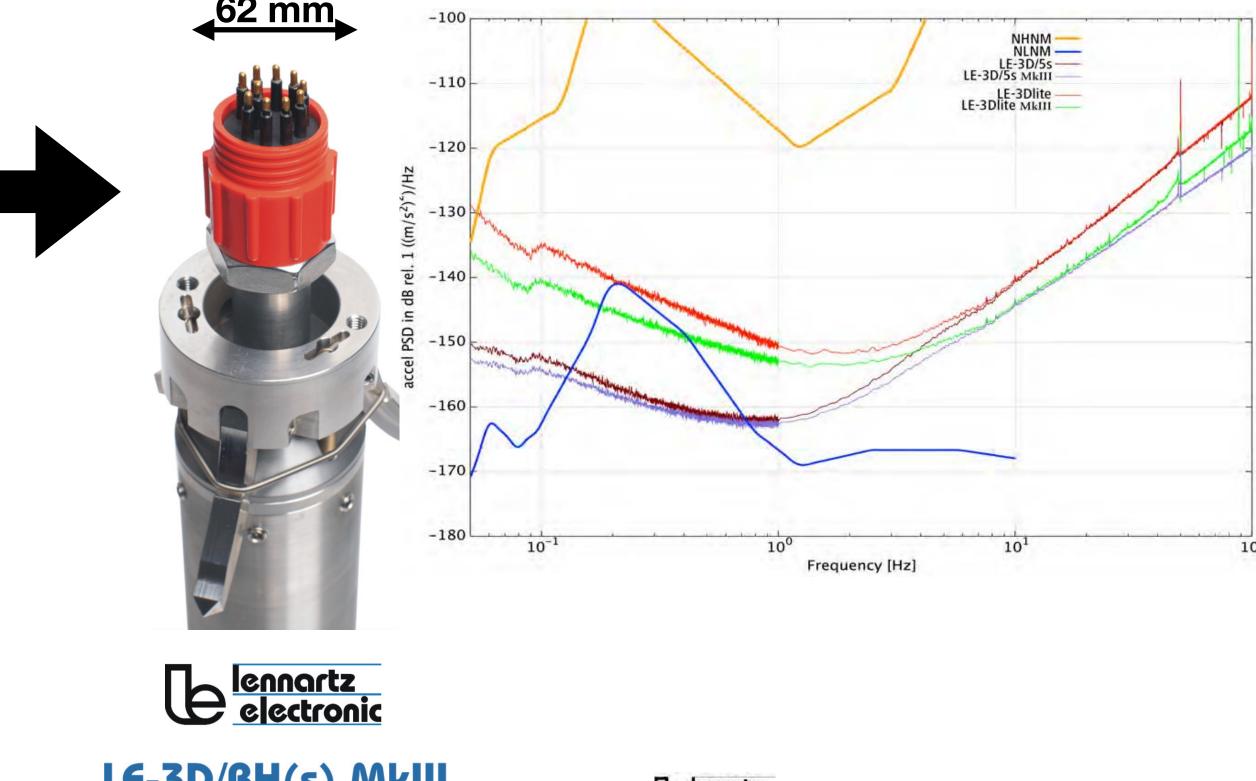
Cottessen drilling and installation

- Drilling reached 250 m depth.
- Casing and cementing of the Cottessen borehole did not go as planned...
 - After drilling inside the casing to clear cement, usable diameter was less than 97 mm
 - Glass fibre had to be cemented inside the casing

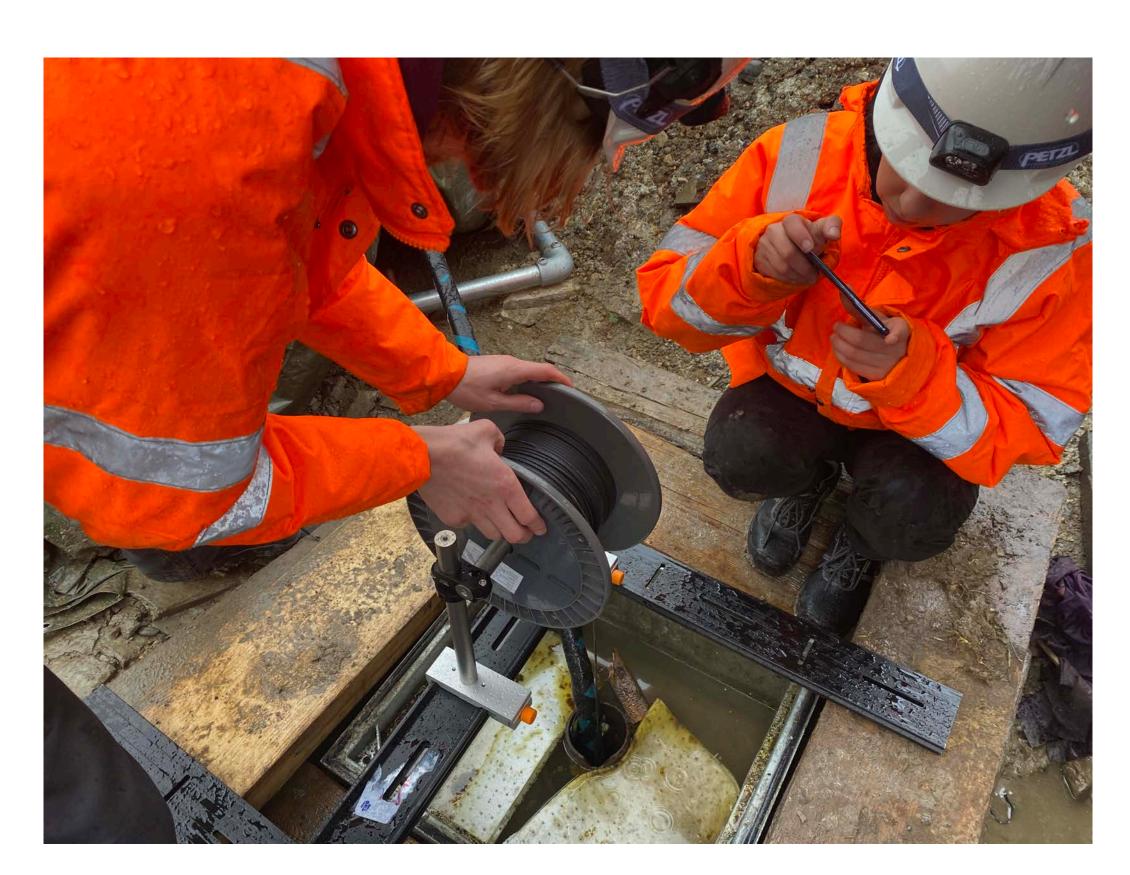
Cottessen drilling and installation

- Drilling reached 250 m depth.
- Casing and cementing of the Cottessen borehole did not go as planned...
 - After drilling inside the casing to clear cement, usable diameter was less than 97 mm
 - Glass fibre had to be cemented inside the casing

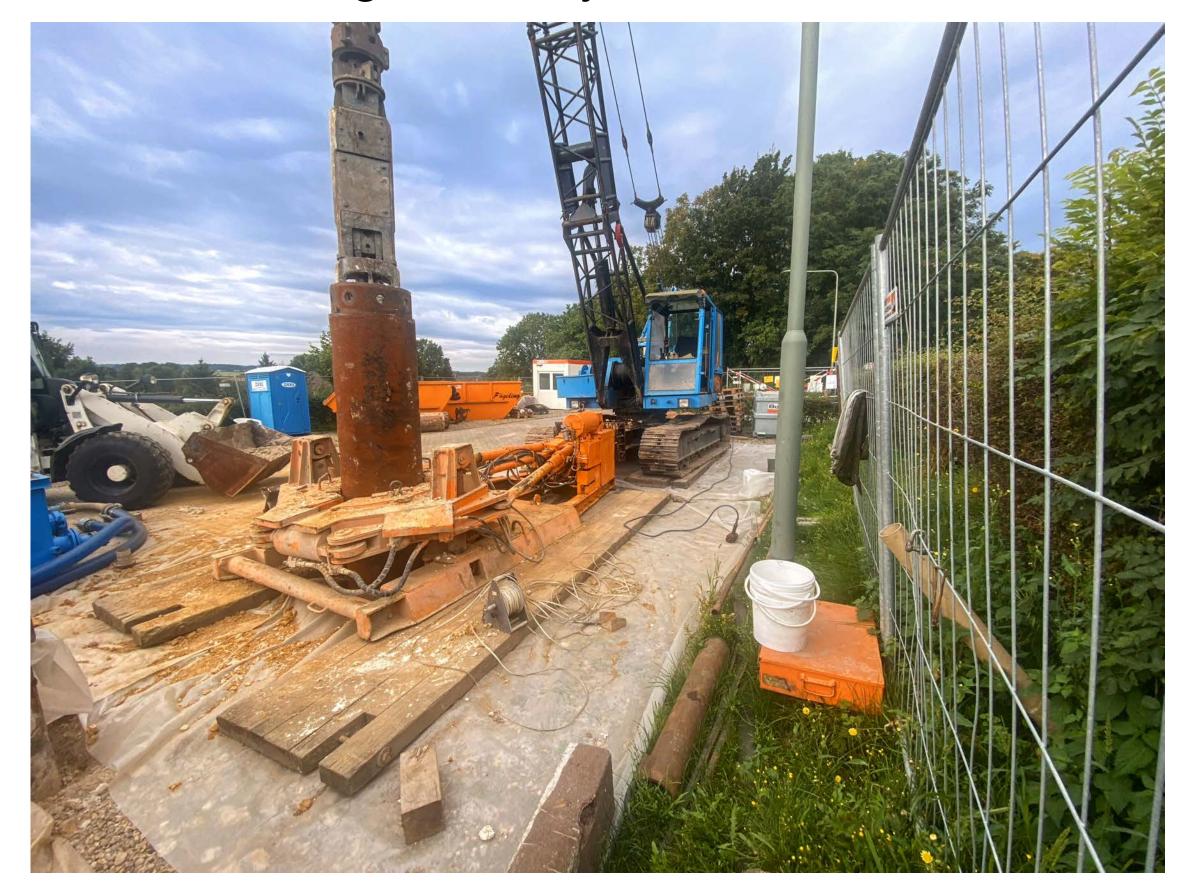
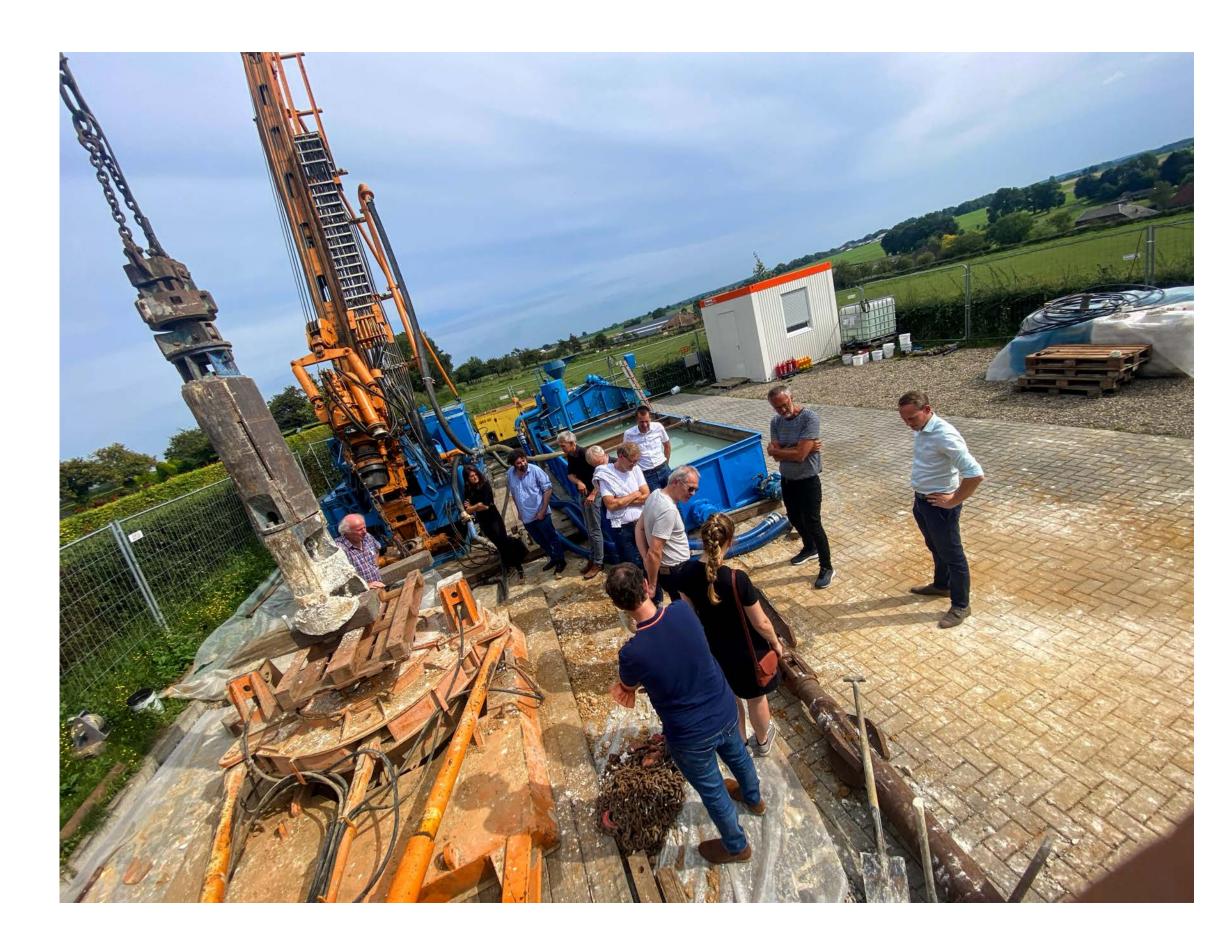
Banholt drilling and installation

- Drilling reached 250 m depth, but bottom 50 m were lost.
- Drill pipes were stuck in the borehole and remained behind as casing, cemented in place.
- Borehole is straight and dry months after.

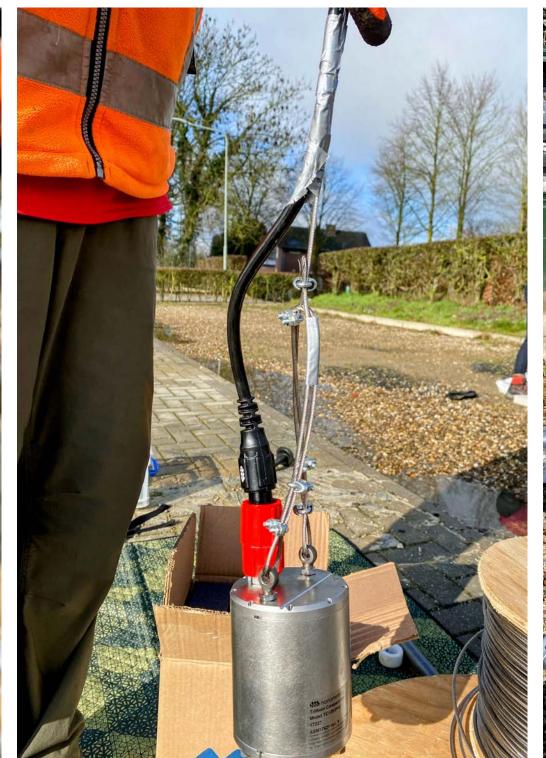
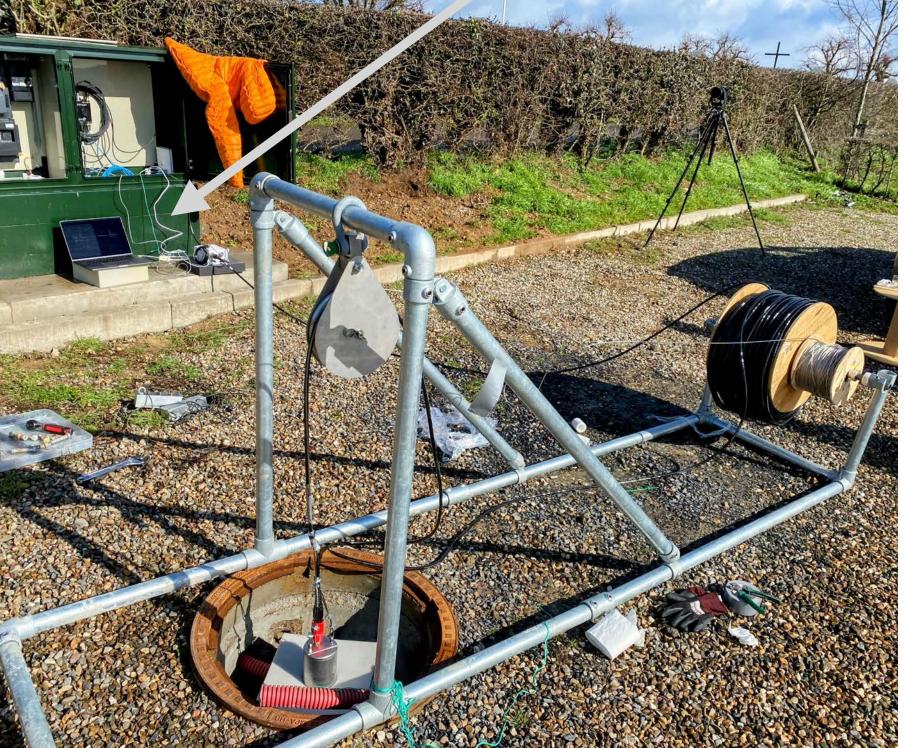
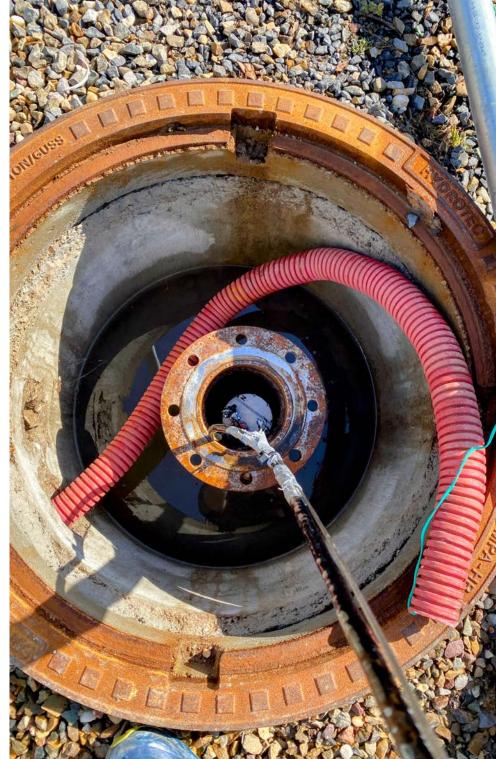
Banholt drilling and installation

- BH Data cable is damaged and will be replaced under warranty by Nanometrics.
- A winch system was used for lowering and hoisting the payload.

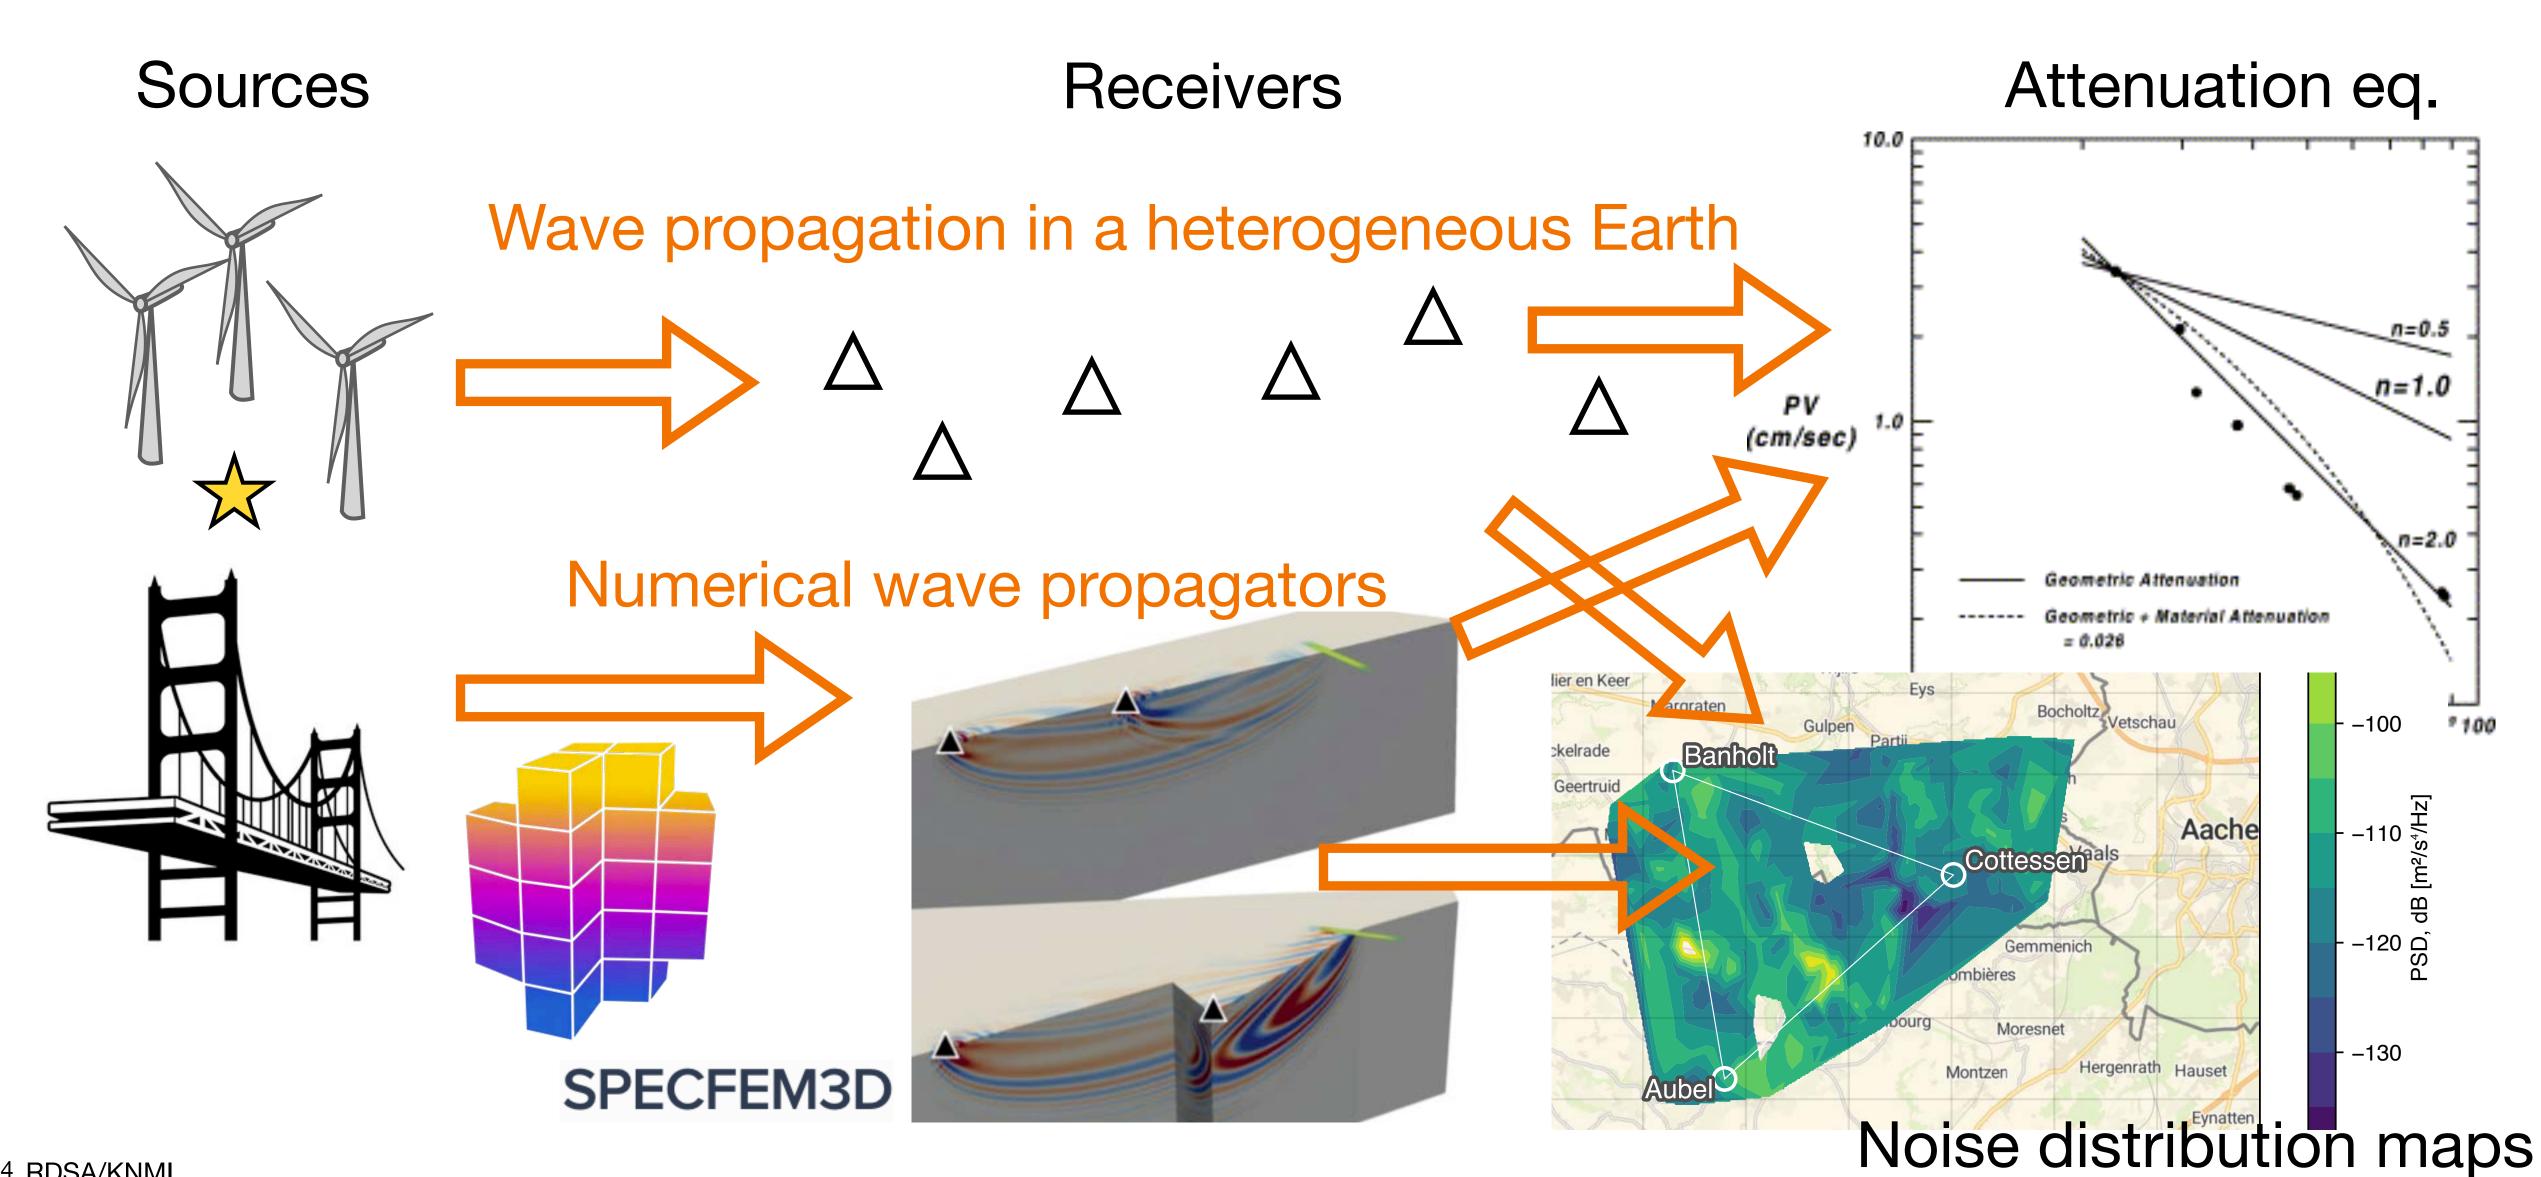
Attenuation relation - observations and models
