QUAD testbox

Fred Hartjes
NIKHEF

Nikhef/Bonn LepCol meeting
February 25, 2019

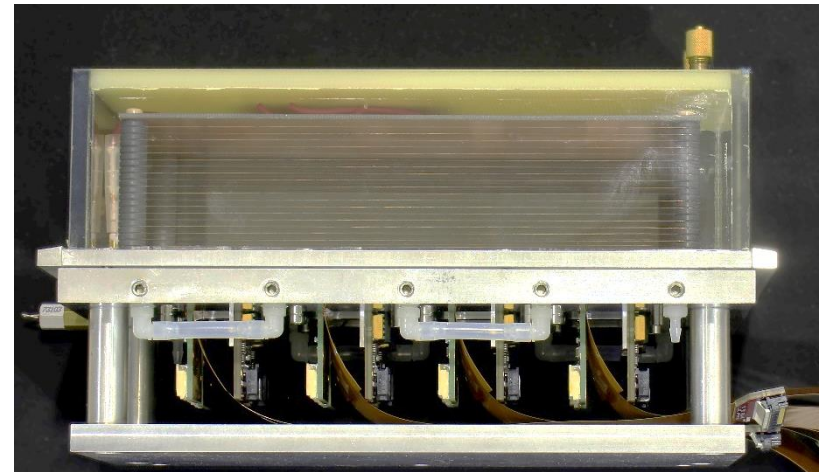
Status testbox

- **Done**
- All 8 QUADs in the testbox can have HV (grid voltage)
- Field cage finished and tested
 - Including the external HV connections
- Field shaping wires above chip to chip joint added
 - Additional HV channel
- Measure coordinates of all chips
 - Make LabVIEW program
- Assemble parts for laser setup
 - Add moisture sensor in gas hood
- Check gas tightness, O₂ and water diffusion

- **To be done**
 - Make all HV grid and central guard connections (2 x 8)
 - Add 5th HV channel to LabVIEW control program
- Install liquid cooling system
- Temporary DAQ with one or two SPIDR boards (lacking concentrator firmware)
- Repair flex quad17 (accident)
- **Can be brought into operation this month**

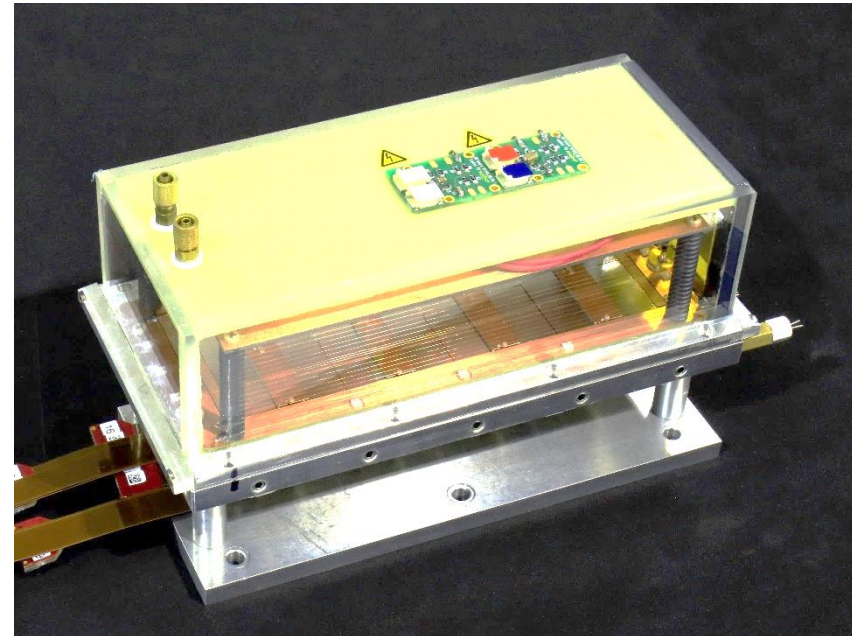
Testbox under gas

- All 8 quads installed
- No leaks (< 0.1 ml/min)
 - Initial leak cured
- O₂ diffusion very small
 - We can get $C_{O_2} < 30$ ppM
 - Uncertainty of O₂ meter reading
 - Old testbox ≥ 800 ppM
- Moisture level
 - 700 ppM, slowly going down
 - Outgassing of materials
 - Glass fibre epoxy, araldite
 - Old testbox 3000 – 4000 ppM

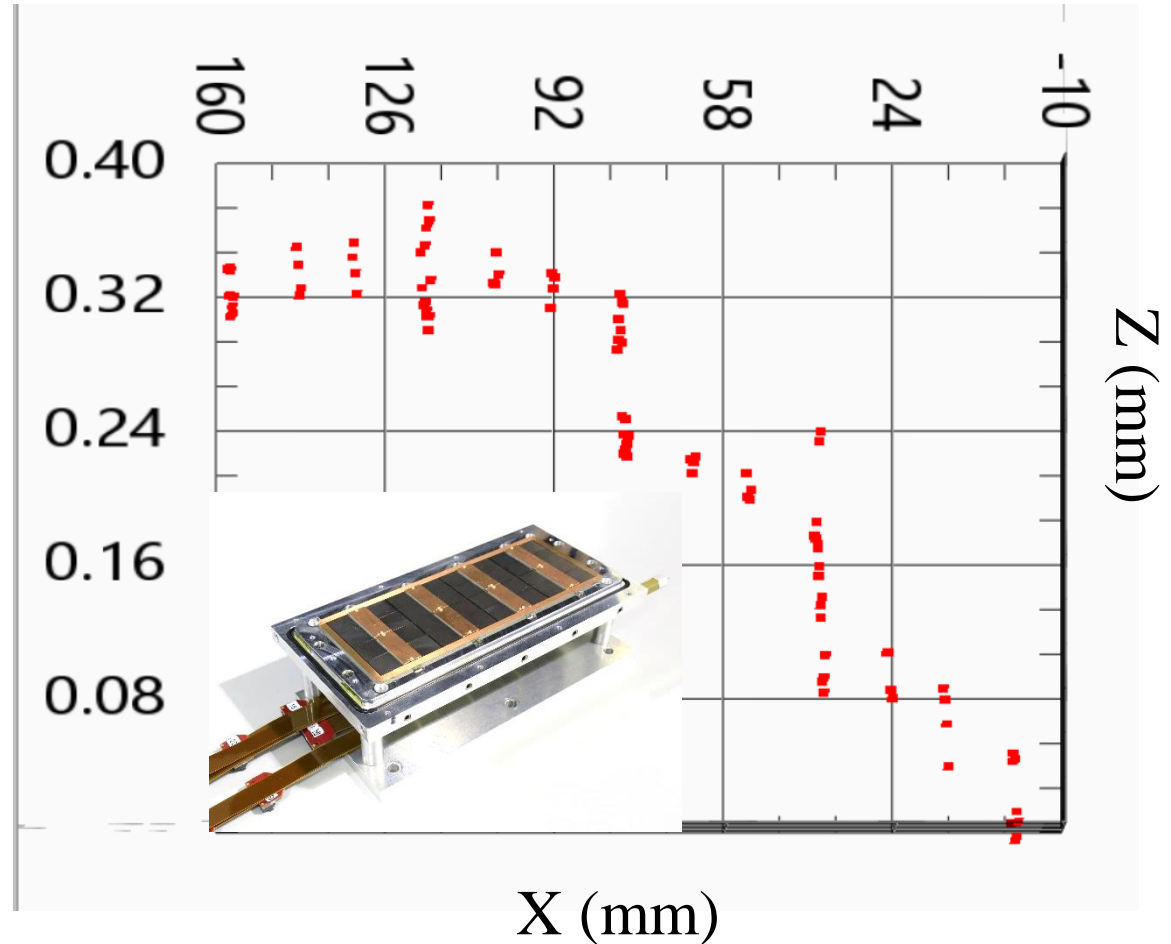
Metrology

- XYZ measurement in two steps across the full length and width
- Base plate very bad flatness
 - More than 300 μm
- Corresponds with variations in thickness of the plate
 - \Rightarrow underside may be well flat
- Some torsion in Y
 - Two chips tilted
 - 100 and 150 μm

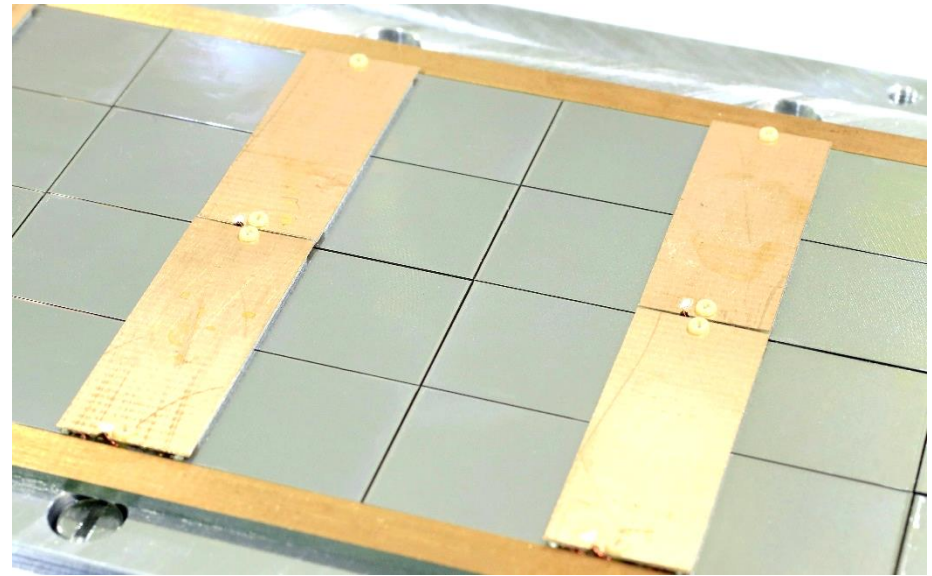
1. Tilted chips

- Take all quads off
- Examine all edges for extruding chips
- Reinstall quads such that the extruding edges are on the outer side
 - We have more clearance at the boundary quad – guard

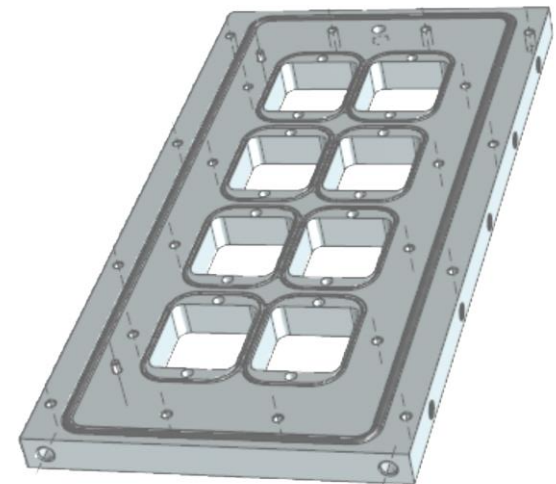
2. Machine top surface of base plate (Oscar)

- Requires ~ 1 week
- Involves some risks
 - Grid damage
 - Damage thin HV wires

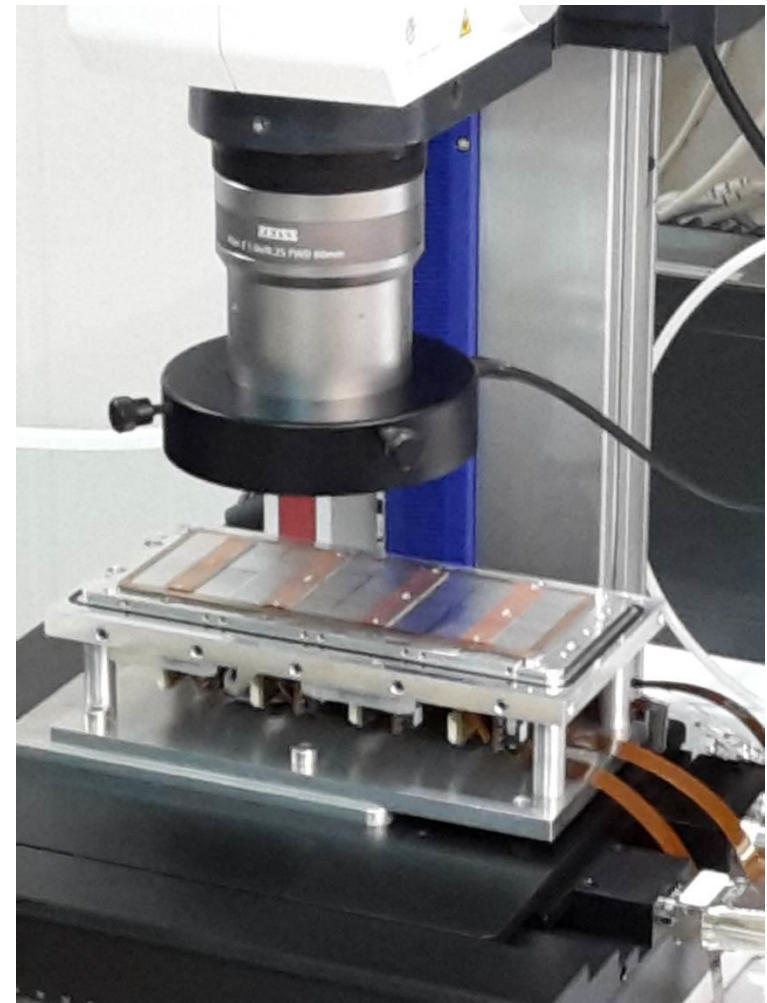
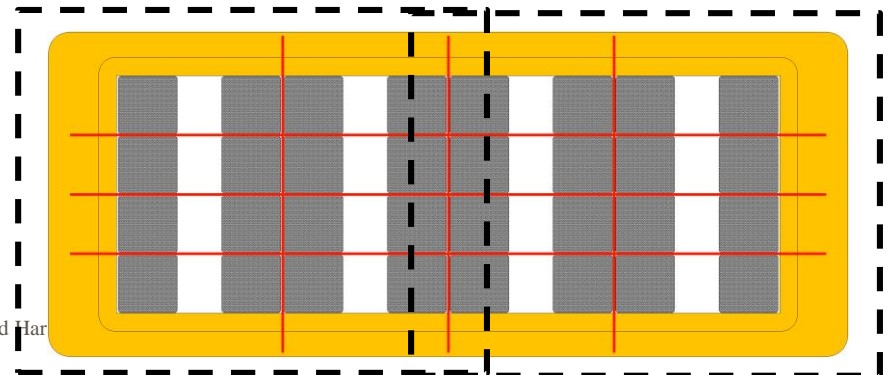
Measuring chip position

- Use the alignment microscope with LabVIEW controlled XY stage
 - Stage range 100 x 100 mm => we have to do it in two steps with a number of points in overlap
- Use LabVIEW program to move to all measuring points
 - XY by manual fine adjustment, automatic coordinate recording
 - Z by autofocusing of microscope => **coordinate recording by hand!**
- Also measurement of guard height
- In total $96 + 8$ (overlap) + 12 (guard) = 116 points to measure
- One point may take ~ 1 min
